Management of fugitive dust (coal ash dust) issues:

A case study of Matimba power station

Presented by: Matlaleng Mamabolo

27 February 2025

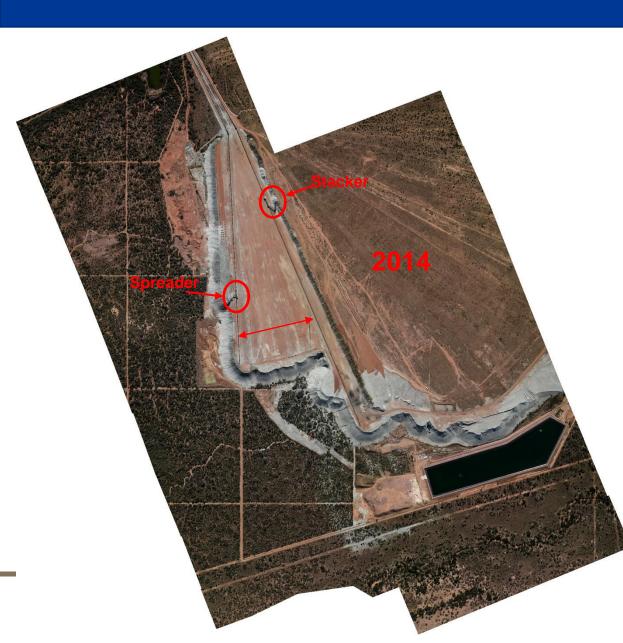
Ash Disposal Facility: Major Incident (Stacker Fire 2013/14)

- Stacker machine got burnt and was out of service for approximately 12 months.
- Spreader was the only available machine to sustain the station's operations.
- Gap between Stacker and Spreader widened and were no longer running in parallel.
- Operations remained normal despite the gap between the machines.

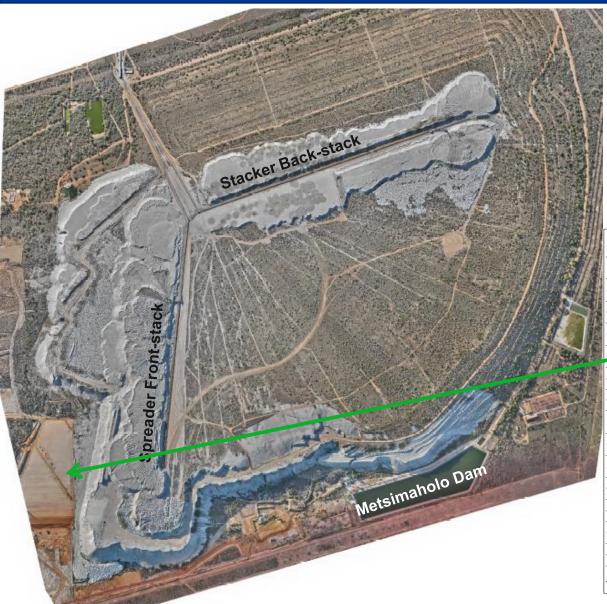
Ash Disposal Facility: Current Status

- The ADF is sitting with larger areas of exposed ash that are causing dust plumes during windy weather conditions.
- The demand for water dust suppression has increased to more than the capability of the pumping capacity.
- Dust cover using topsoil requires the exposed ash areas to be reshaped and leveled first.
- Reshaping and rehabilitation of the ADF requires additional yellow plant on site.
- Phase I lining project commenced in January 2023 and expected to be completed in March 2025.

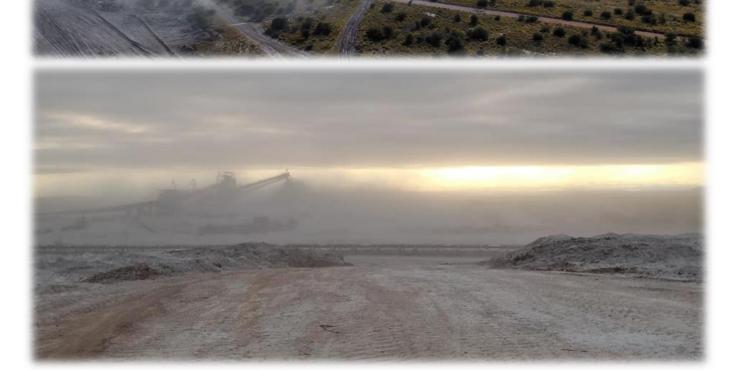
Dust problems

- Large areas of exposed ash resulted in excessive dust issues, leading to: community complaints, strained relationship with key stakeholders (neighbouring farmers, mining houses, Authorities, SAHRC and our own employees).
- Dust plumes aesthetically changed the landscapes in and around the ADF.
- The other issues brought by the dust were: standing time cost on the lining project, operational backlogs due to visibility issues the ash plant would stop from time to time and thus, this introduced stack emissions problems.
- The average fugitive dust fallout during that period that period was in excess of **750mg/m²/day.**
- The convectional (soil cover and water) way of dealing with dust was proving to be inefficient; thus, the application of chemical dust suppression was adopted.

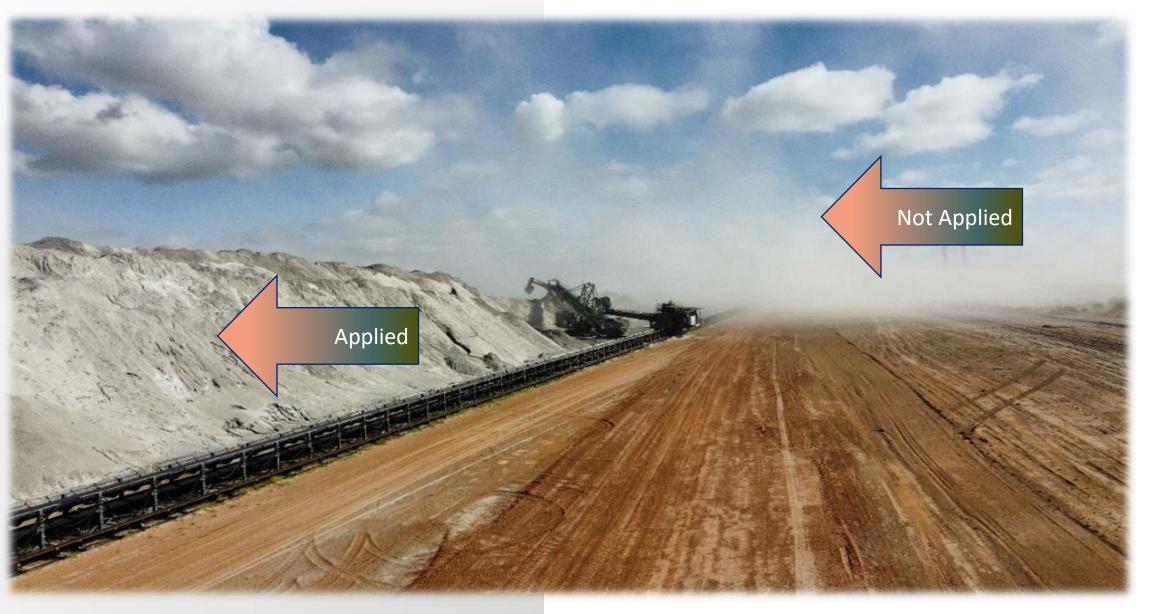
The efficacy of the chemical was realised within days of application

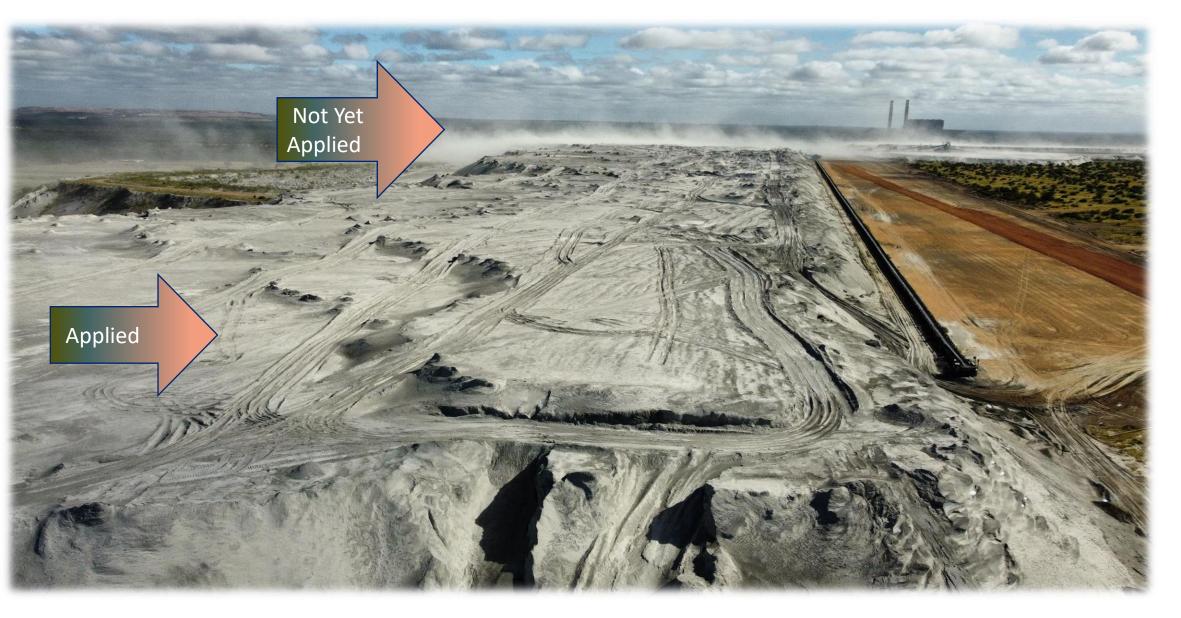
The efficacy of the chemical was realised within days of application
