REPORT ON THE JOINT PRELIMINARY INVESTIGATION INTO THE COMPLIANCE PROFILE OF UPL SOUTH AFRICA (PTY) LIMITED

3 October 2021

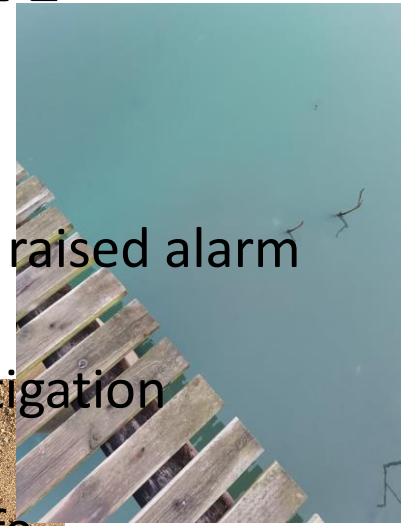
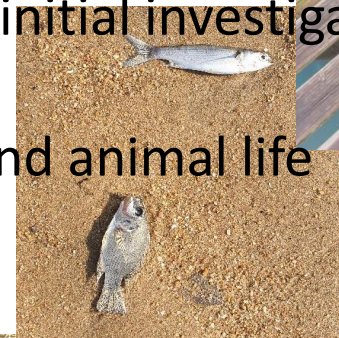
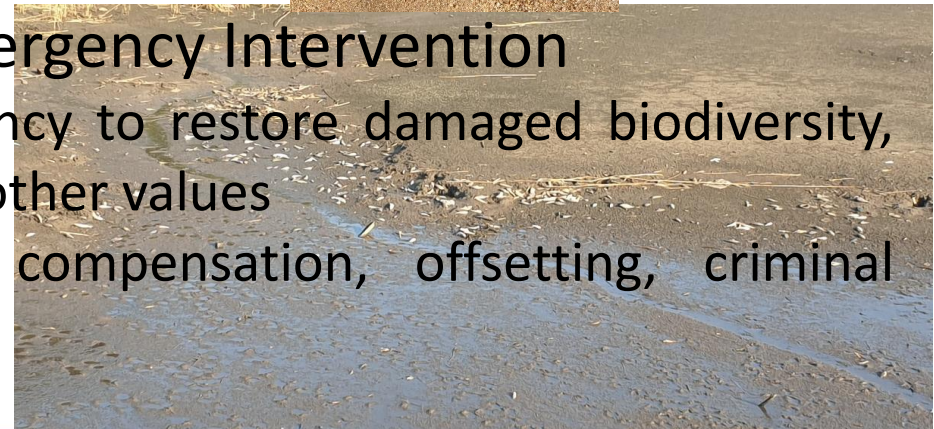
- Post Spill
 - Ezemvelo Rangers discovered the spill (blue water) and raised alarm
 - Massive fish die-off
 - Water body found to be highly toxic during initial investigation
 - 1 species (limited individuals) found alive
 - Chemicals compounds toxic to both plant and animal life
 - Functioning of estuary and NR collapsed
 - Extent of contamination to be determined
- Key Considerations – Post Emergency Intervention
 - Remedial actions post emergency to restore damaged biodiversity, uMhlanga Nature Reserve and other values
 - Restorative justice including compensation, offsetting, criminal liability, etc.
 - Cost recovery
